Historic Structure Report

*Building 25
Enlisted Men's Barracks
Fort Hancock, New Jersey
Sandy Hook Unit
Gateway National Recreation Area*

**BUILDING 25
ENLISTED MEN'S BARRACKS
Fort Hancock**

February 2002

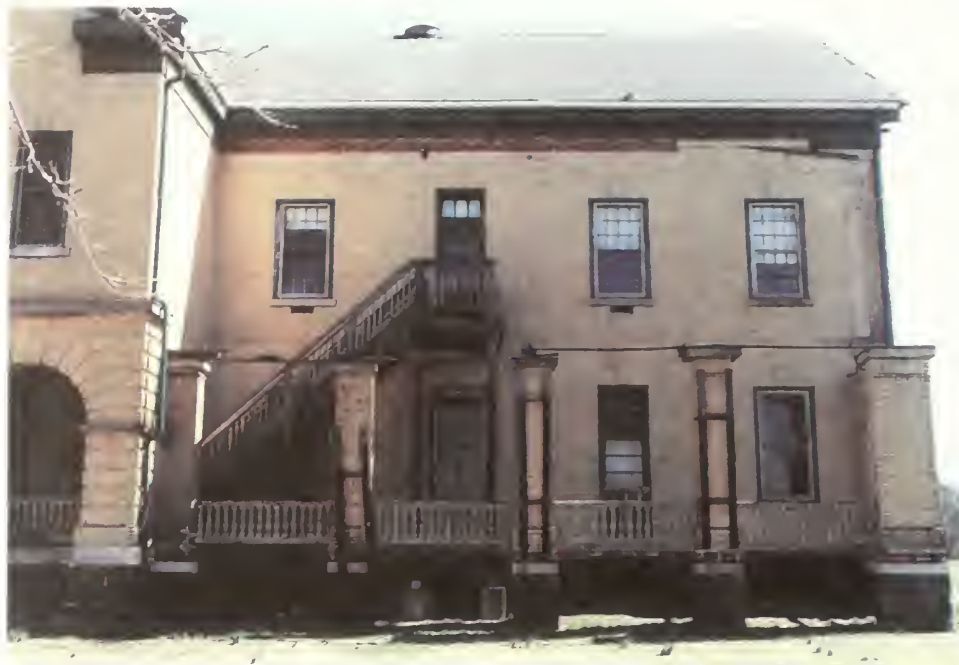
Figure 74. West elevation, showing replacement box cornice and fire escape.

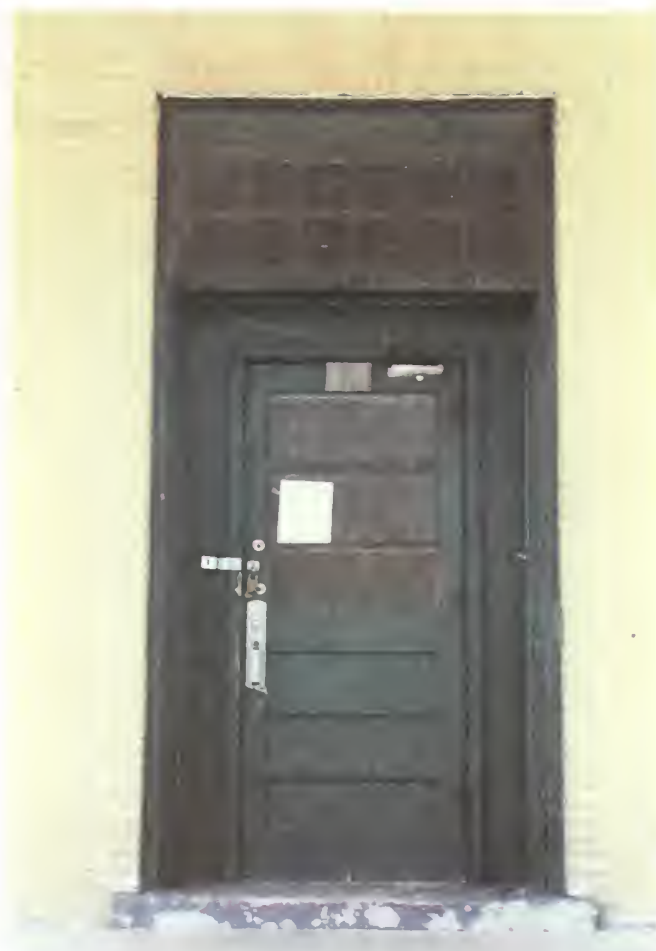
Figure 75. East elevation, first-story doorway, showing perimeter infill with replacement door, and original transom.

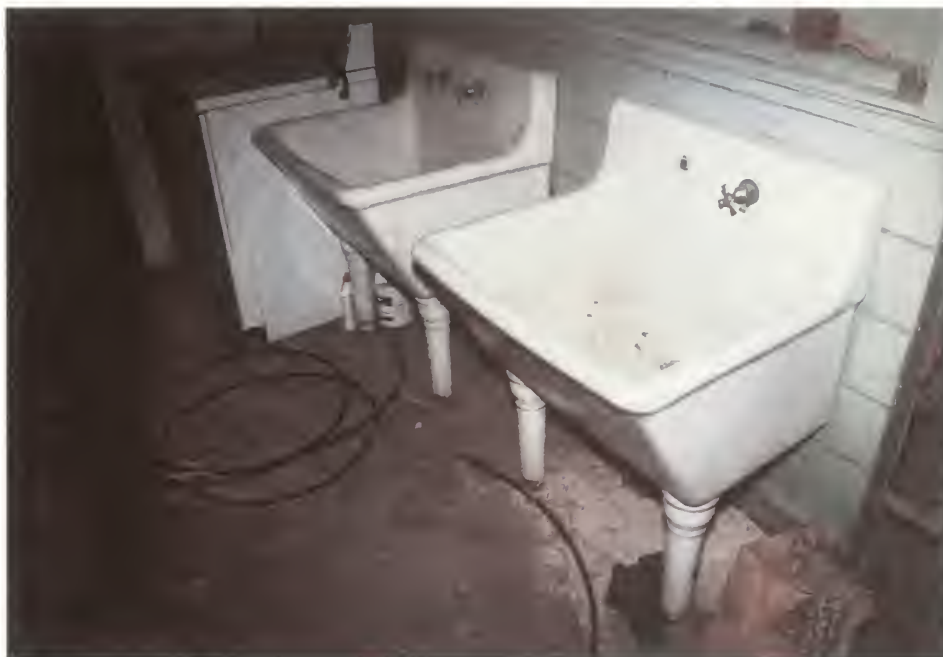
Figure 76. North side of basement, partition and laundry sinks in northeast corner.

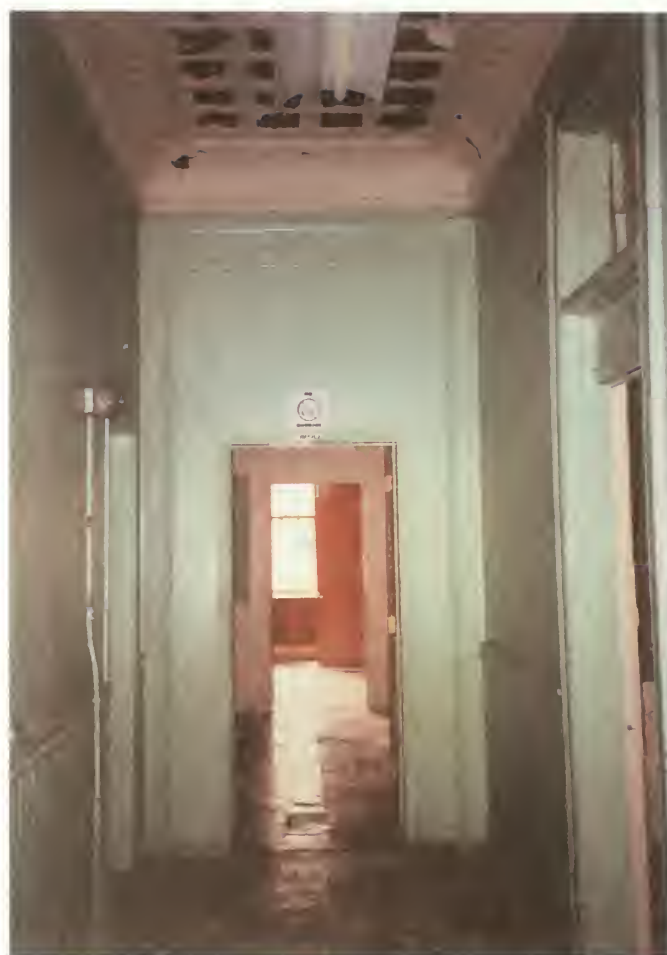
Figure 79. Doorway from side hall to mess room, showing perimeter infill for replacement door and covered transom.

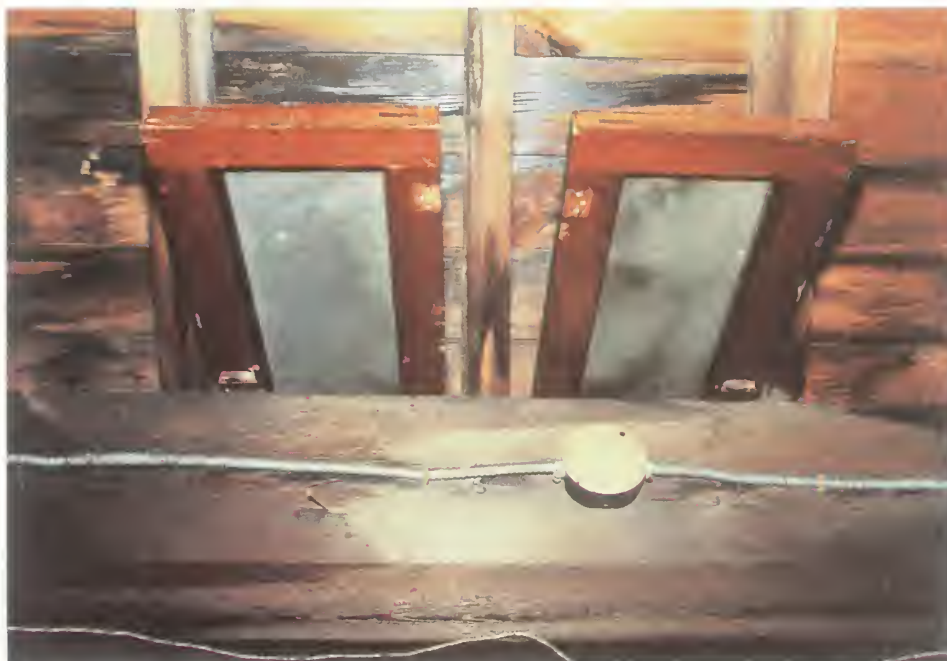
Figure 80. Pantry cupboard doors stored in south side of attic.

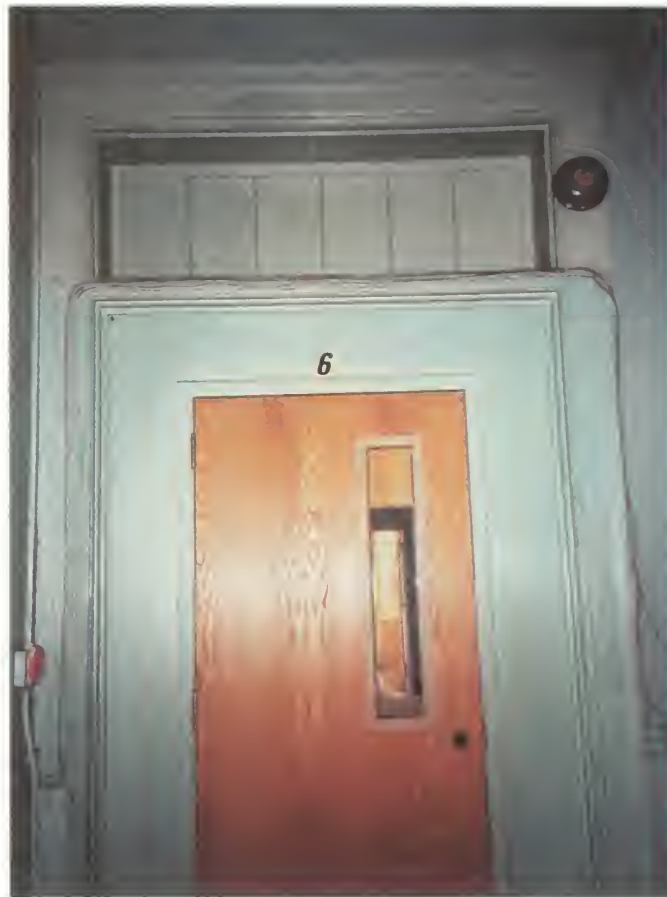
Figure 82. Doorway from center hall to south dormitory, showing perimeter infill with replacement door, and painted transom.

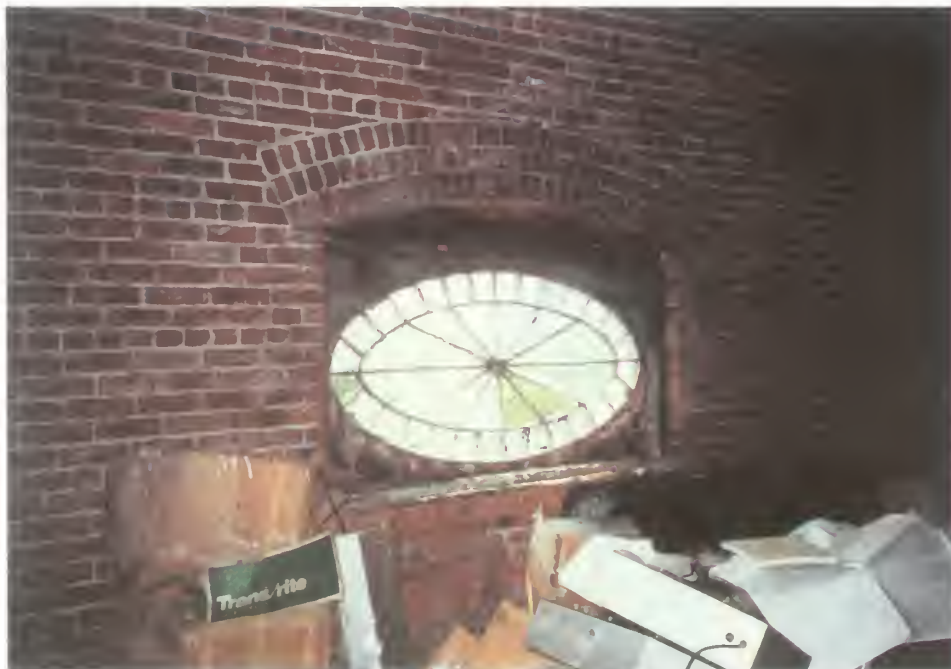
Illumination is provided by bare light bulbs screwed into sockets attached to the exposed electrical lines. These supplement the natural light obtained from the gable oculi (fig. 83).

Figure 83. South side of attic, south wall, showing interior construction of opening for oculus.
